EVALUATION AND REPAIR OF EXISTING POST-TENSIONED BUILDINGS WITH PAPER-WRAPPED TENDONS EXPERIENCING CORROSION DAMAGE

K. DIRK BONDY, S.E.

PTI Journal, V. 4, No. 2, December 2006. Received and reviewed under Institute Journal publication policies. Copyright ©2006, Post-Tensioning Institute. All rights reserved, including the making of copies unless permission is obtained from the Post-Tensioning Institute. Pertinent discussion will be published in the next issue of the PTI Journal if received within 3 months from the publication.

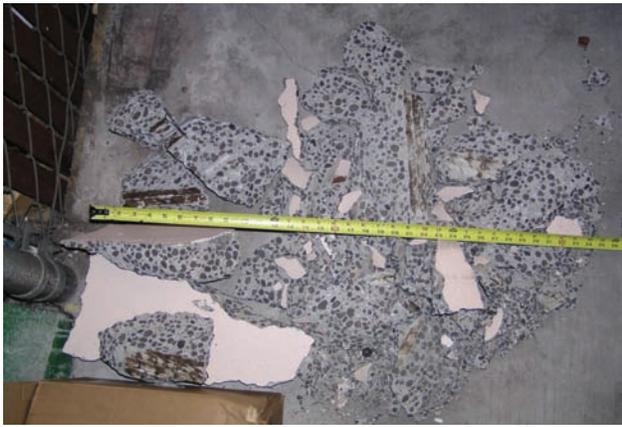
An engineer or contractor is often first called to evaluate a project potentially experiencing corrosion damage when sections (sometimes large sheets) of concrete suddenly dislodge and fall, Figures 1 and 2.

The mechanism for the spalled concrete is the fact that the tendon is experiencing the growth of corrosion buildup, and this pressure will become great enough to dislodge concrete where the cover is the least. Over time, however, the base metal of the tendon will deteriorate entirely, leaving only a void.

Fig. 1 – Dislodged Concrete

The first step is to remove all loose concrete throughout the slab system and to clean the exposed reinforcement of all corrosion buildup. It is then important to make every rea-

sonable effort to protect the reinforcement from further moisture intrusion. The areas of delaminated concrete must be patched with a cementitious material that bonds well to and is stronger than the existing concrete. Cracks in the concrete must be filled with structural grade epoxy for their entire length and depth. Finally, consideration should be given to providing an elastomeric coating on the slab, even if the slab is not directly exposed to weather.

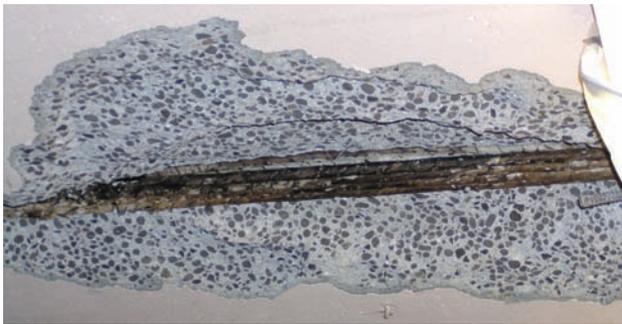
Fig. 2 – Corroded Tendons

The next step is to address the loss of prestressing reinforcement. In a paper-wrapped tendon system it is very difficult to remove the corroded tendons, and virtually impossible to replace them due to the lack of a greased sheathing duct. Typically, the most structurally effective and cost efficient way to replace the lost strength is to externally provide post-tensioning tendons below the slab.

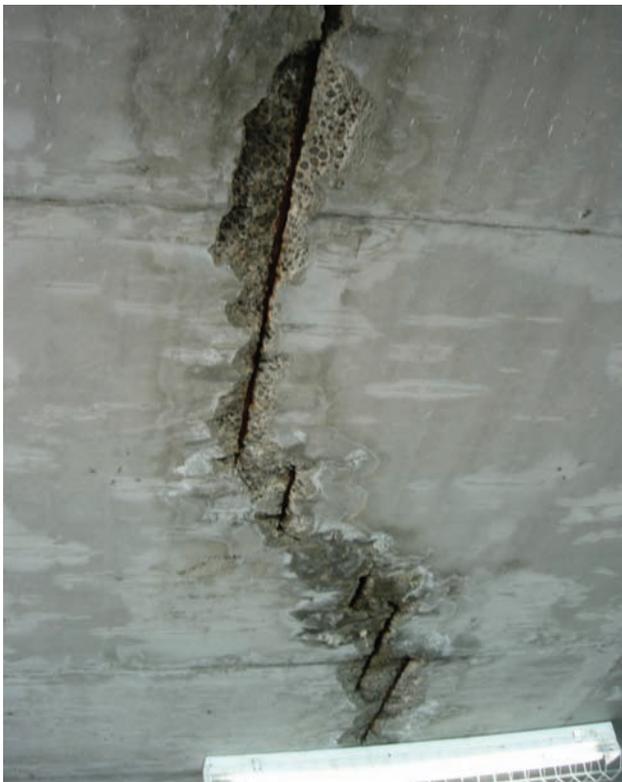
Signs that the reinforcement in the slab is corroding include water staining at the underside of the slab, rust deposits and efflorescence, Figure 3.

Fig. 3 – Water Staining, Rust and Efflorescence at Corroded Reinforcing

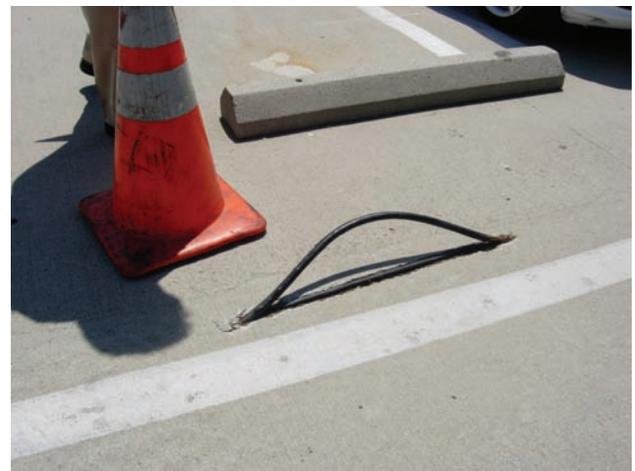
When a tendon which is greased and protected in an extruded plastic sheathing breaks, the result is often a “looping” out of the slab of a portion of the tendon, not necessarily near the point of tendon rupture. The energy stored in the prestressed tendon causes a recoil effect when it is broken, and because there is no appreciable friction the strand is free to rapidly decrease its length. The tendon will find the point of least resistance and often buckle out of the concrete at that location, Figure 4.

Fig. 4 – A Broken Tendon in Extruded Sheathing

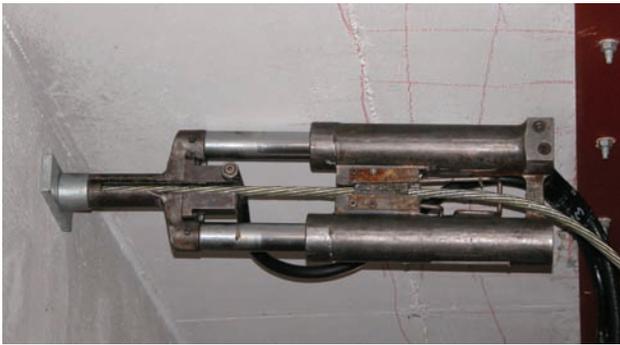
Fig. 5 – The Underside of a Hydraulic Jack

However, the same test will give inaccurate results if friction exists along the strand, or if the strand has bonded due to corrosion buildup. This is typically the case when the only protection for the tendons is wrapped paper. What is really being measured by the jack is the sum total of all resistance to movement of that tendon. This includes the temporary bond to the concrete due to rust and corrosion, interlock of the corrosion buildup and concrete, friction of the un-greased tendon (the paper rarely is adequate to maintain the grease) against the concrete as well as any remaining prestress.

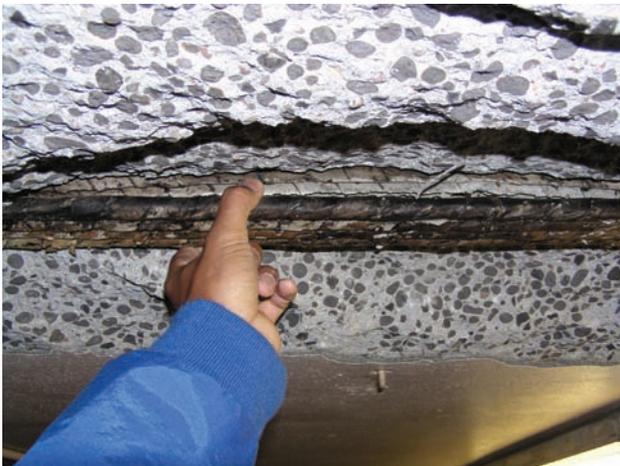
The simple fact that it is often difficult and takes substantial jacking force to remove long tendons even when they are known to be broken should be reason enough for the evaluating engineer to be skeptical of lift-off results on paper-wrapped tendons. An engineer or contractor can gain a much better understanding of the condition of the tendons by exposing one to two feet of tendon and exploring the ability of the tendon to be moved out of plane by a crow bar, screwdriver, or even by hand. A $\frac{1}{2}$ " ϕ fully stressed tendon is extremely difficult to move out of plane by any of these methods.

Fig. 6 – Broken Tendons Being Moved By Hand

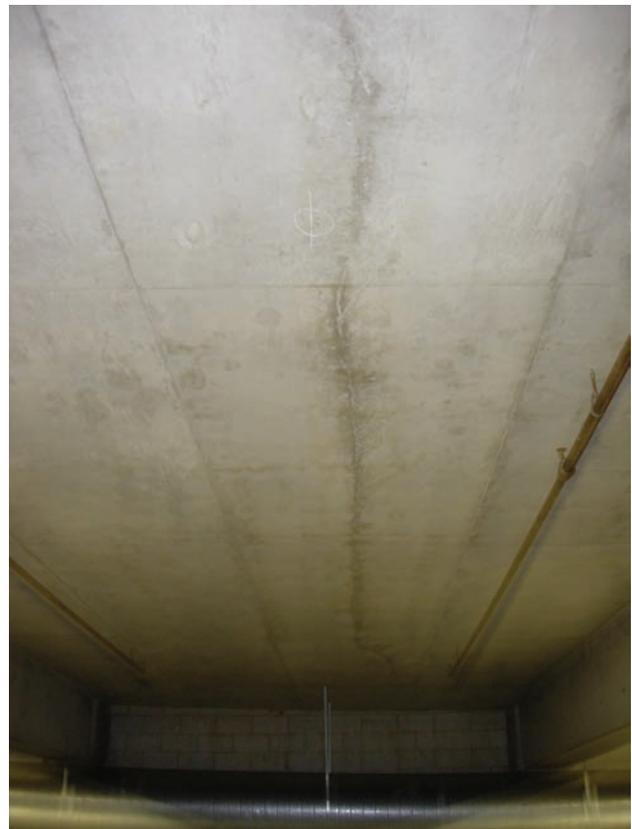
Flexural cracking in the slabs of older beam-and-slab parking structures is often observed running parallel to the beams in the positive moment area near the slab midspan. A similar slab crack is also commonly seen at a distance of approximately 4 to 6 feet from the beams. The latter crack occurs at this location because it corresponds to the termination of the top slab mild rebar, which is typically the only mild rebar in the slab. This crack emanates from the top, but may also be visible from the bottom. When the crack has penetrated the full depth of the slab and is visible from both top and bottom a potentially dangerous situation exists. There is by definition no pre-compression in the concrete at that location and it is almost certain that a significant amount of prestressing tendons have been compromised. Further, there is effectively no mechanism available to resist the slab bending moments. Slabs in this condition are standing only due to their ability to act as cantilevers off the beam.

Fig. 7 – Full Length Mid-span Crack Parallel to Beams

In a parking structure, once the crack becomes a through-crack the vehicular traffic will alternately load each side of the crack, causing a dynamic shearing effect at this location. Eventually pieces of rubble will become noticeable in the crack due to this grinding effect. Again, this is potentially a very dangerous situation.

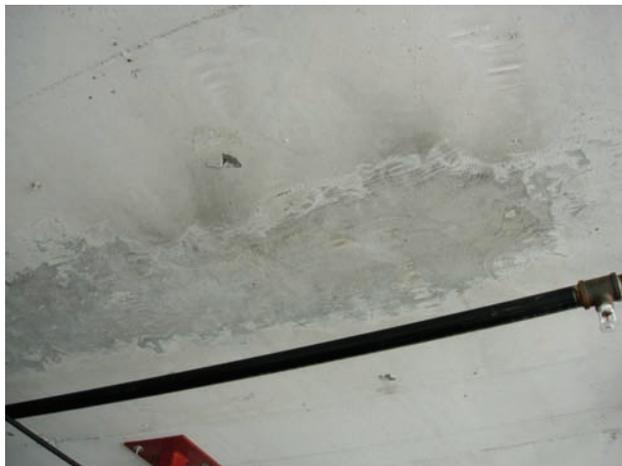
Fig. 8 – Patched Concrete

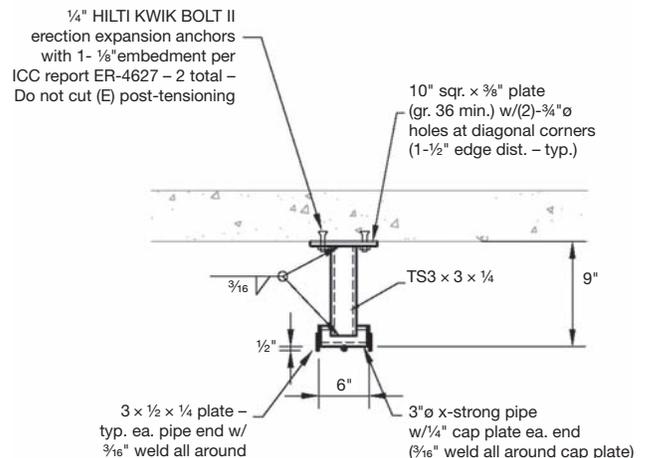
Fig. 9 – Detail of King Post

External post-tensioning is the process of placing tendons and hardware below the slab and stressing the tendons to effectively jack the slab up. The benefit of the stressed tendons is two-fold. First, an active “balancing” force is applied to the slab to offset the effects of the gravity loads. Secondly, the harped or double harped shape of the tendons provides the added strength of a truss, with the post-tensioning as the bottom chord and the concrete as the top chord.

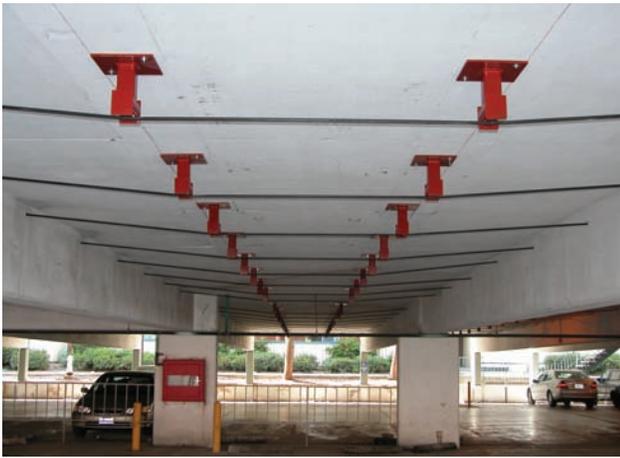
Fig. 10 – Double Harped External Post-Tensioning in a One-Way Slab

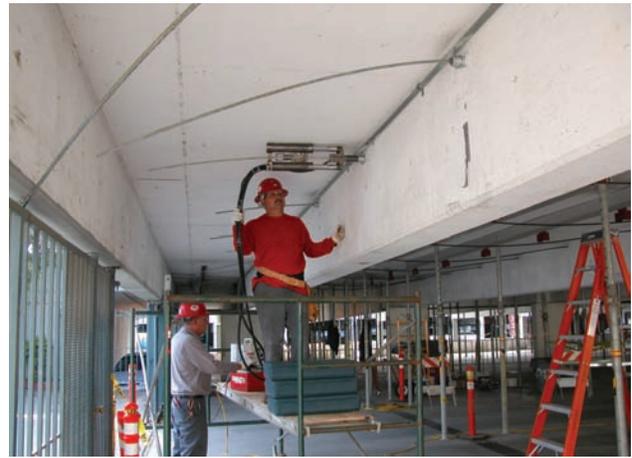
Fig. 13 – Stressing the Galvanized Tendons

Galvanized greased strands in thick extruded plastic sheathing are used in combination with galvanized anchors and anchor caps to provide a durable strengthening system. The cut tendons are treated with a corrosion resistant coating prior to capping the anchorage.

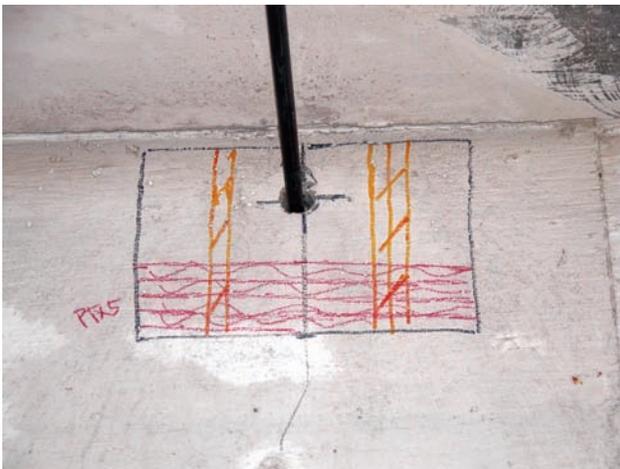
Fig. 11 – X-Ray Markings on a Existing Post-Tensioned Beam

In an EPT application it is always necessary to drill through the existing concrete in order provide a path for the tendons and an anchorage location. If the existing structure is post-tensioned it may be necessary to x-ray in order to prevent damaging existing tendons.

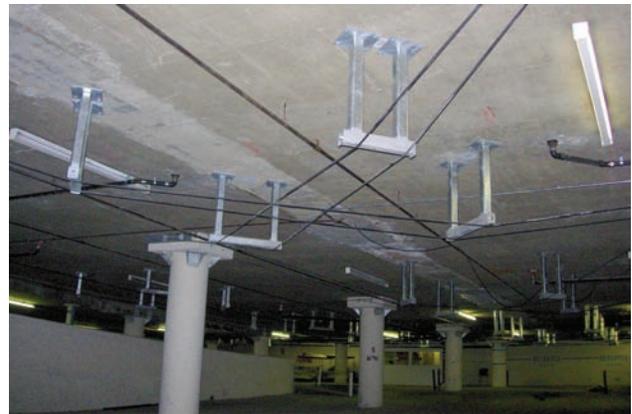
Fig. 14 – A Double Harp Two-Way EPT System

The same approach to repair can be applied to two-way flat plate structures. However, given the limited anchoring locations (typically only the columns) the layout needs to involve more creativity, Figures 14 and 15.

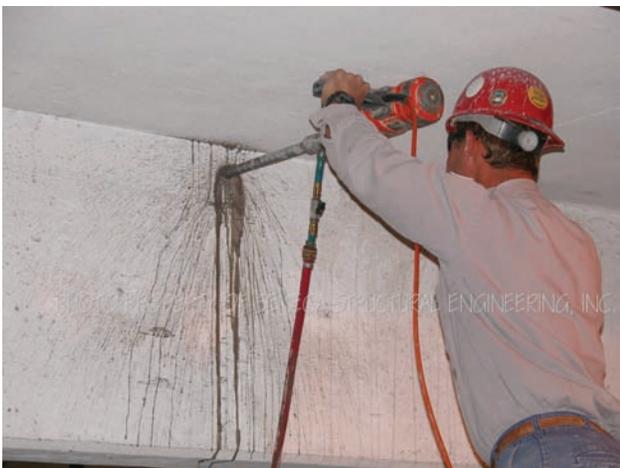
Fig. 12 – Drilling Through an Existing Post-Tensioned Beam

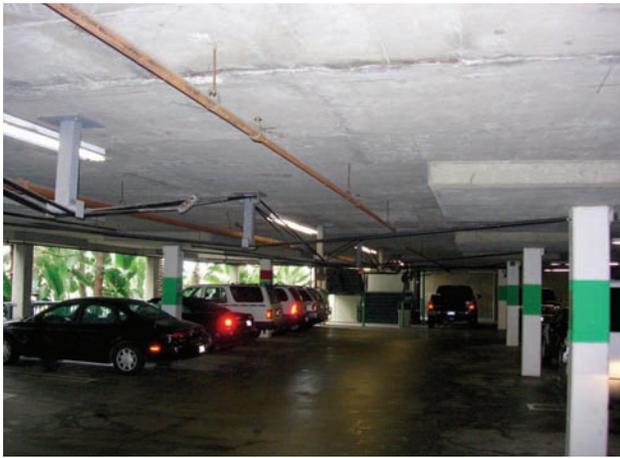
Fig. 15 – A Single Harp Two-Way EPT System

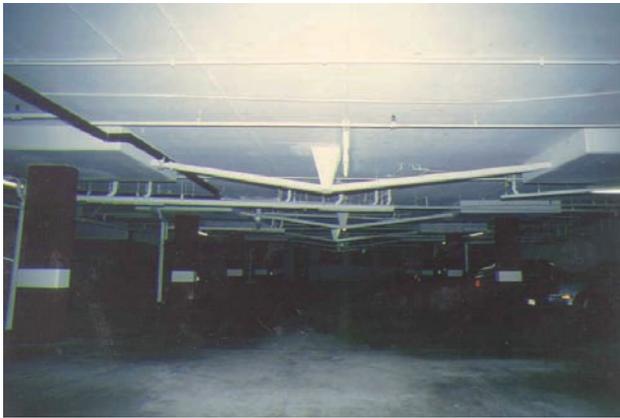
Fig. 16 – Fireproofed EPT Tendons and Hardware

Depending upon the particular situation, fireproofing of the tendons and hardware may or may not be required. This decision ultimately lies with the building official and will depend upon whether or not the external tendons are considered

primary or secondary reinforcement. The requirement may also depend upon whether or not the concrete cover over the original tendons satisfies today's fire rating requirements.

Most building departments will allow the engineer some leeway with respect to the fireproofing issue. In a number of cases the addition of a fire sprinkler system in lieu of applied fireproofing has been accepted as a viable alternative, particularly when a similar new structure would require a fire sprinkler system and when the concrete cover over the existing tendons is less than required by today's codes.
